Sauers Engineering, Inc.

MEMORANDUM

Subject: Spalding Community Services District
Sewer Lift Station Evaluation

Date: November 4, 2024

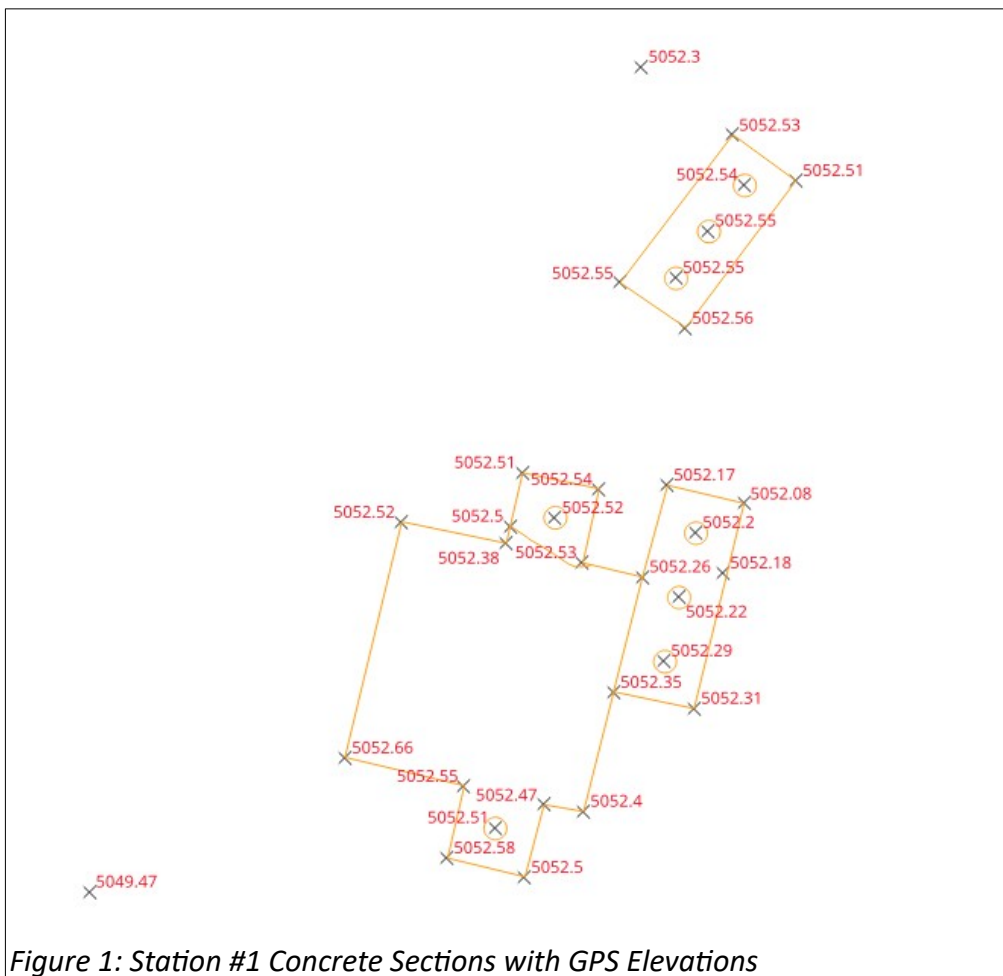
The general areas of settling can be interpreted from Figures 1 and 2 which show the elevations of edges of concrete and center of manholes for Stations 1 and 2 respectively. At station #1, measurements show that the concrete slab around the pump wet wells is typically about 0.2 -0.3 ft lower than the western edge of the generator slab and the slab over the valve vault. For Station #2, differences in elevation between the various slabs is minimal. Although Station #4 was not surveyed, the visual evidence of the settling issues is very apparent. In some ways, the issues at Station 4 are more problematic because portions of the station were

The settling is demonstrated by the fact that the concrete slabs and lids which were placed over the top of the pumping wet wells have dropped over time. Specifically, at Station #1, the slab over the wet wells was surveyed to be about 3-4 inches lower than the other concrete on site. Original drawings called out the slabs to have the same finish grade elevation. Operators have reportedly had to trim the HDPE pipe inside of the manhole cover in order to get the lids to sit flush. This is further evidence to support the theory of consolidation of the surrounding soil structure. The bottom end of the vertical HDPE pipe is positioned on native undisturbed soil. As the surrounding soil consolidates, the wet well pipe appears to rise while the concrete and manhole lid appears to fall.

The slab supporting the generator and controls does demonstrate some differential settlement. Figure 1 shows that the generator slab is showing a slight slope toward the direction of the pump wet wells. Elevations are lower in the northeast direction and higher towards the southwest.

If the only issue of concern was with the settling of the compacted soil, a focused solution could remove the problematic fill material around the pumps and wet wells and replace it with a more closely monitored compacted fill or with a slurry cement product that does not require a compaction. Due to the depth of the wet wells, the total volume that would require removal is higher than one would expect. A preliminary estimate suggests that over 100 yd³ would need to be removed and replaced. Additionally, for the Station #1 site, the excavation's proximity to generator and controls could present challenges with shoring such that it might be difficult to not disturb other components.

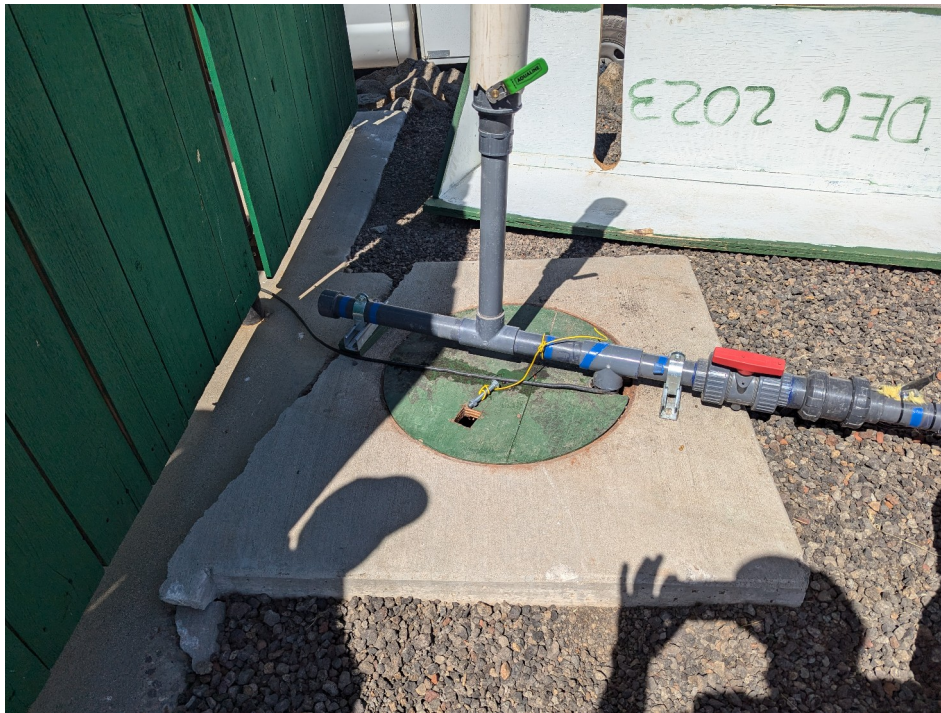
Figure 3: Damaged concrete at Station #1 adjacent to generator and controls slab

One concerning issue with the generator and controls is the cracking shown in the concrete covering the tank access shown in Figure 3. The crack exists between the main slab and a section of concrete slab was extended from the main slab to surround the tank opening manhole. Several contributing factors could contribute to a crack at this location.

- a. As previously discussed, it is apparent that there is a general slope to the northeast in the direction of the wet wells where the pumps reside. The portion of concrete around the opening where damage exists may be less prone to settling due to the manhole risers extending from the top of the tank which will tend to support the concrete from underneath. As the surrounding soil consolidates, the manhole risers will support the slab projection thus causing the described damage.

- b. Proper concrete construction techniques were not followed with the concrete work at this site. The extension over the access to the tank should not have been monolithic with the main slab. This is a classic case where a control joint should have been provided since differential stresses will inevitably cause a crack at the interface. The concrete around the opening on the other end of the tank is constructed in a similar way and it is surprising that a fracture does not exist there.

- c. Lastly, due to the cold winter temperatures in this area and the weight of the generator and electrical controls, a perimeter footing that extends below the potential frost line would have been justified. Moist soil in the winter with freezing conditions could potential cause differential stresses on concrete work.
